ILLINOIS STATE WATER SURVEY

REPORT ON

EXISTING WATER WORKS AT FAIRBURY

August 13, 1914

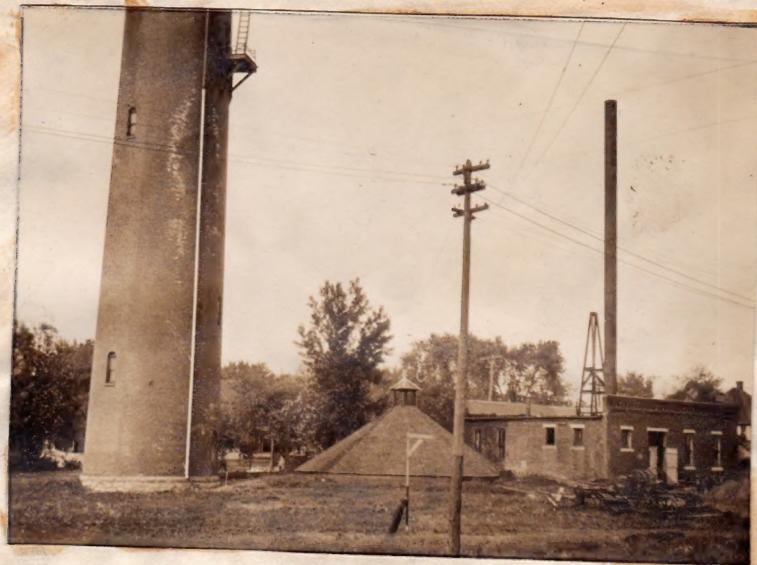
FAIRBURY WATER WORKS

May, 1914
